**POTABLE WATER
STORAGE FACILITIES
INSPECTIONS AND
ASSESSMENTS**

**NAVAL AMPHIBIOUS BASE
LITTLE CREEK
NORFOLK, VIRGINIA**

FPO-1-84(41) OCTOBER 1984

19. ABSTRACT (Continue on reverse if necessary & identify by block number)
In October of 1984, an underwater inspection was conducted at the Naval
Amphibious Base, Little Creek, Norfolk, Virginia to assess the condition of
seven potable water storage facilities.

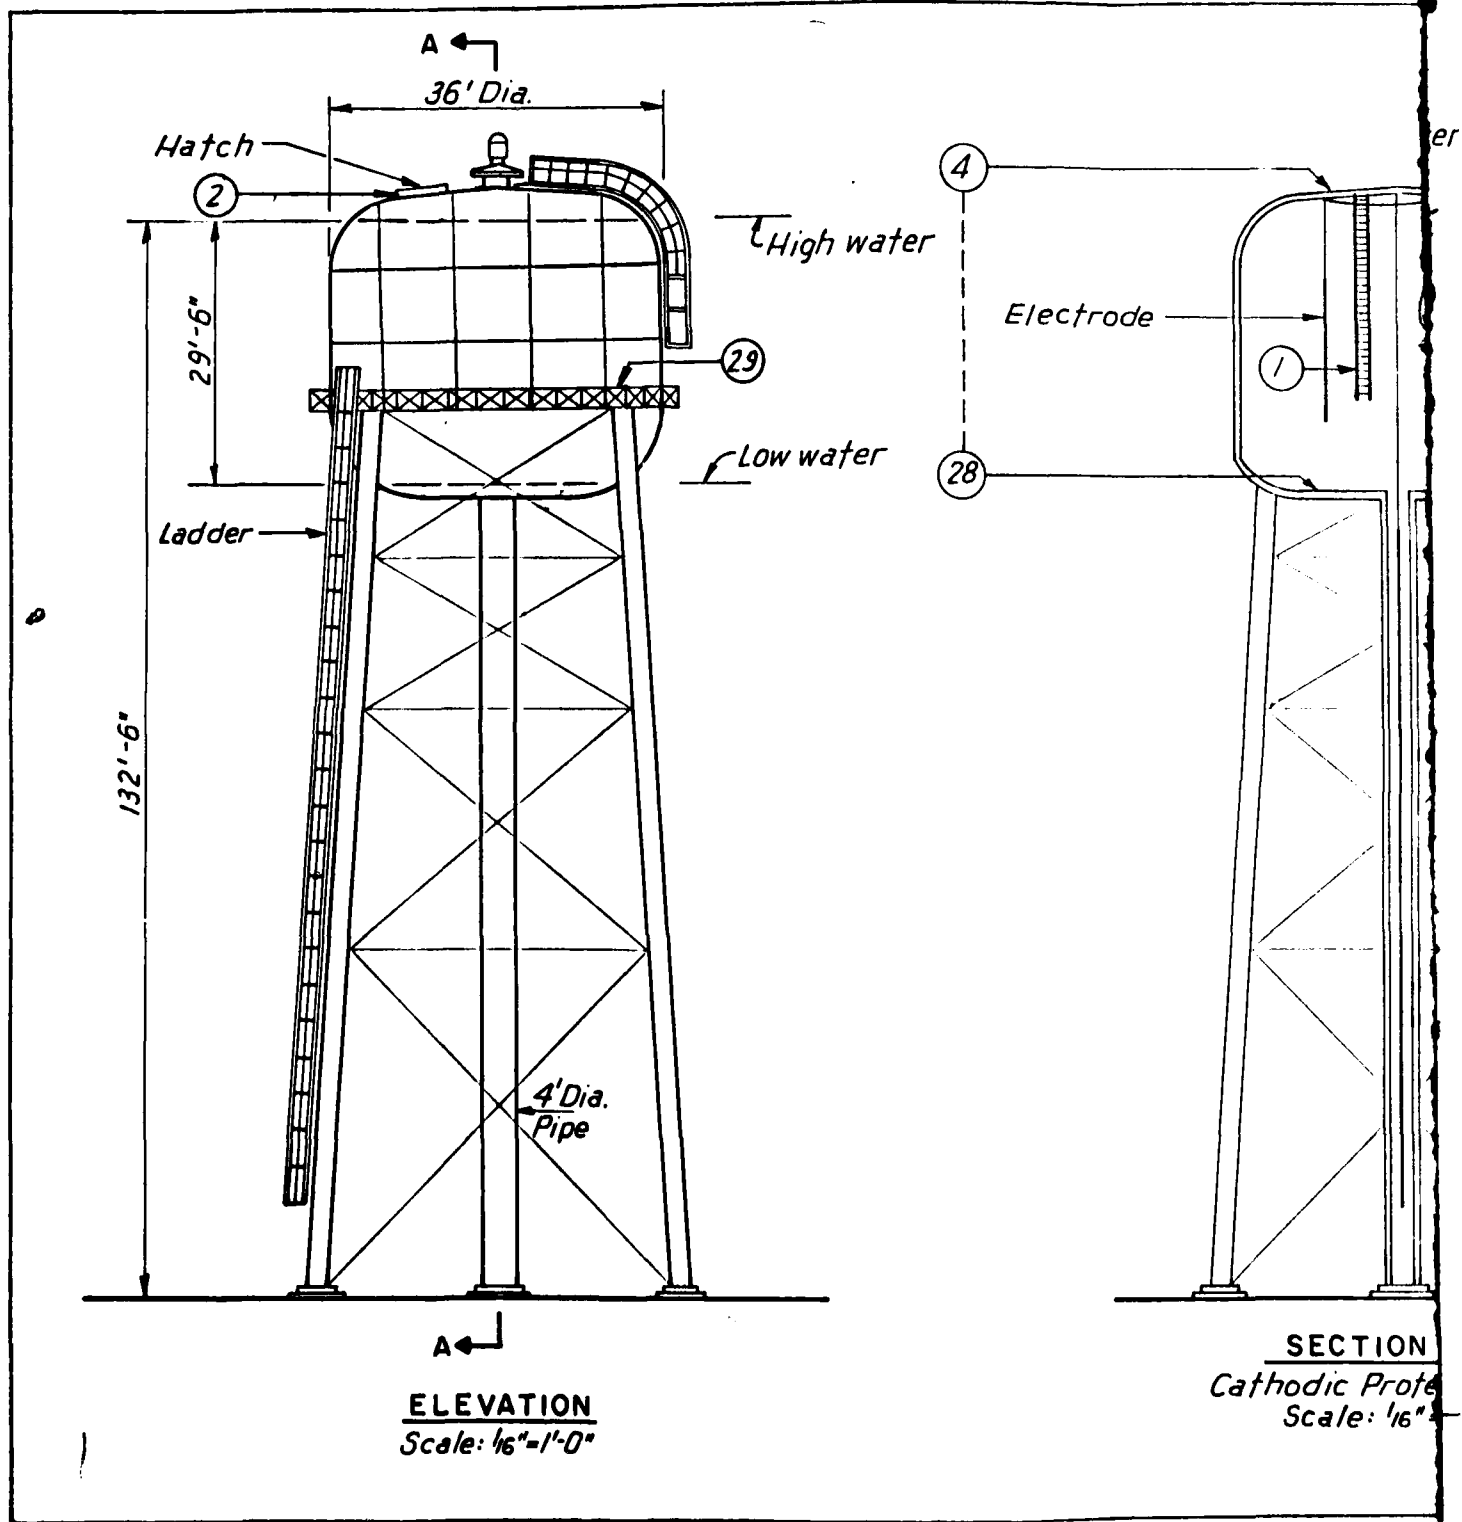
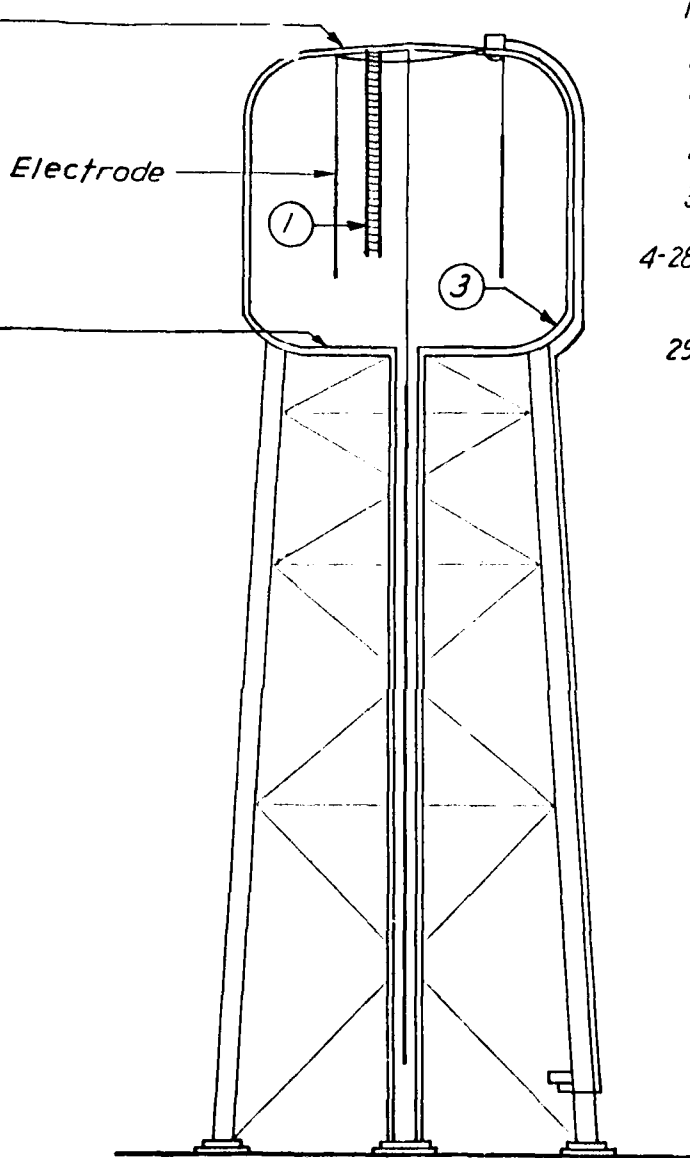
1. Ladder on interior of facility is severely corroded at top.
2. Holes due to corrosion in hatch
3. Areas of light to moderate corrosion on interior.
- 4-28. Ultrasonic thickness measurements. Measurements taken at approximately 2" intervals. Values given in table below.
29. Minor areas of corrosion on floor plate of balcony.

ULTRASONIC THICKNESS MEASUREMENTS			
4	0.30"	16	0.44"
5	0.29"	17	0.40"
6	0.29"	18	0.41"
7	0.29"	19	0.40"
8	0.23"	20	0.36"
9	0.29"	21	0.38"
10	0.31"	22	0.37"
11	0.28"	23	0.36"
12	0.31"	24	0.36"
13	0.31"	25	0.37"
14	0.28"	26	0.37"
15	0.29"	27	0.40"
		28	0.40"

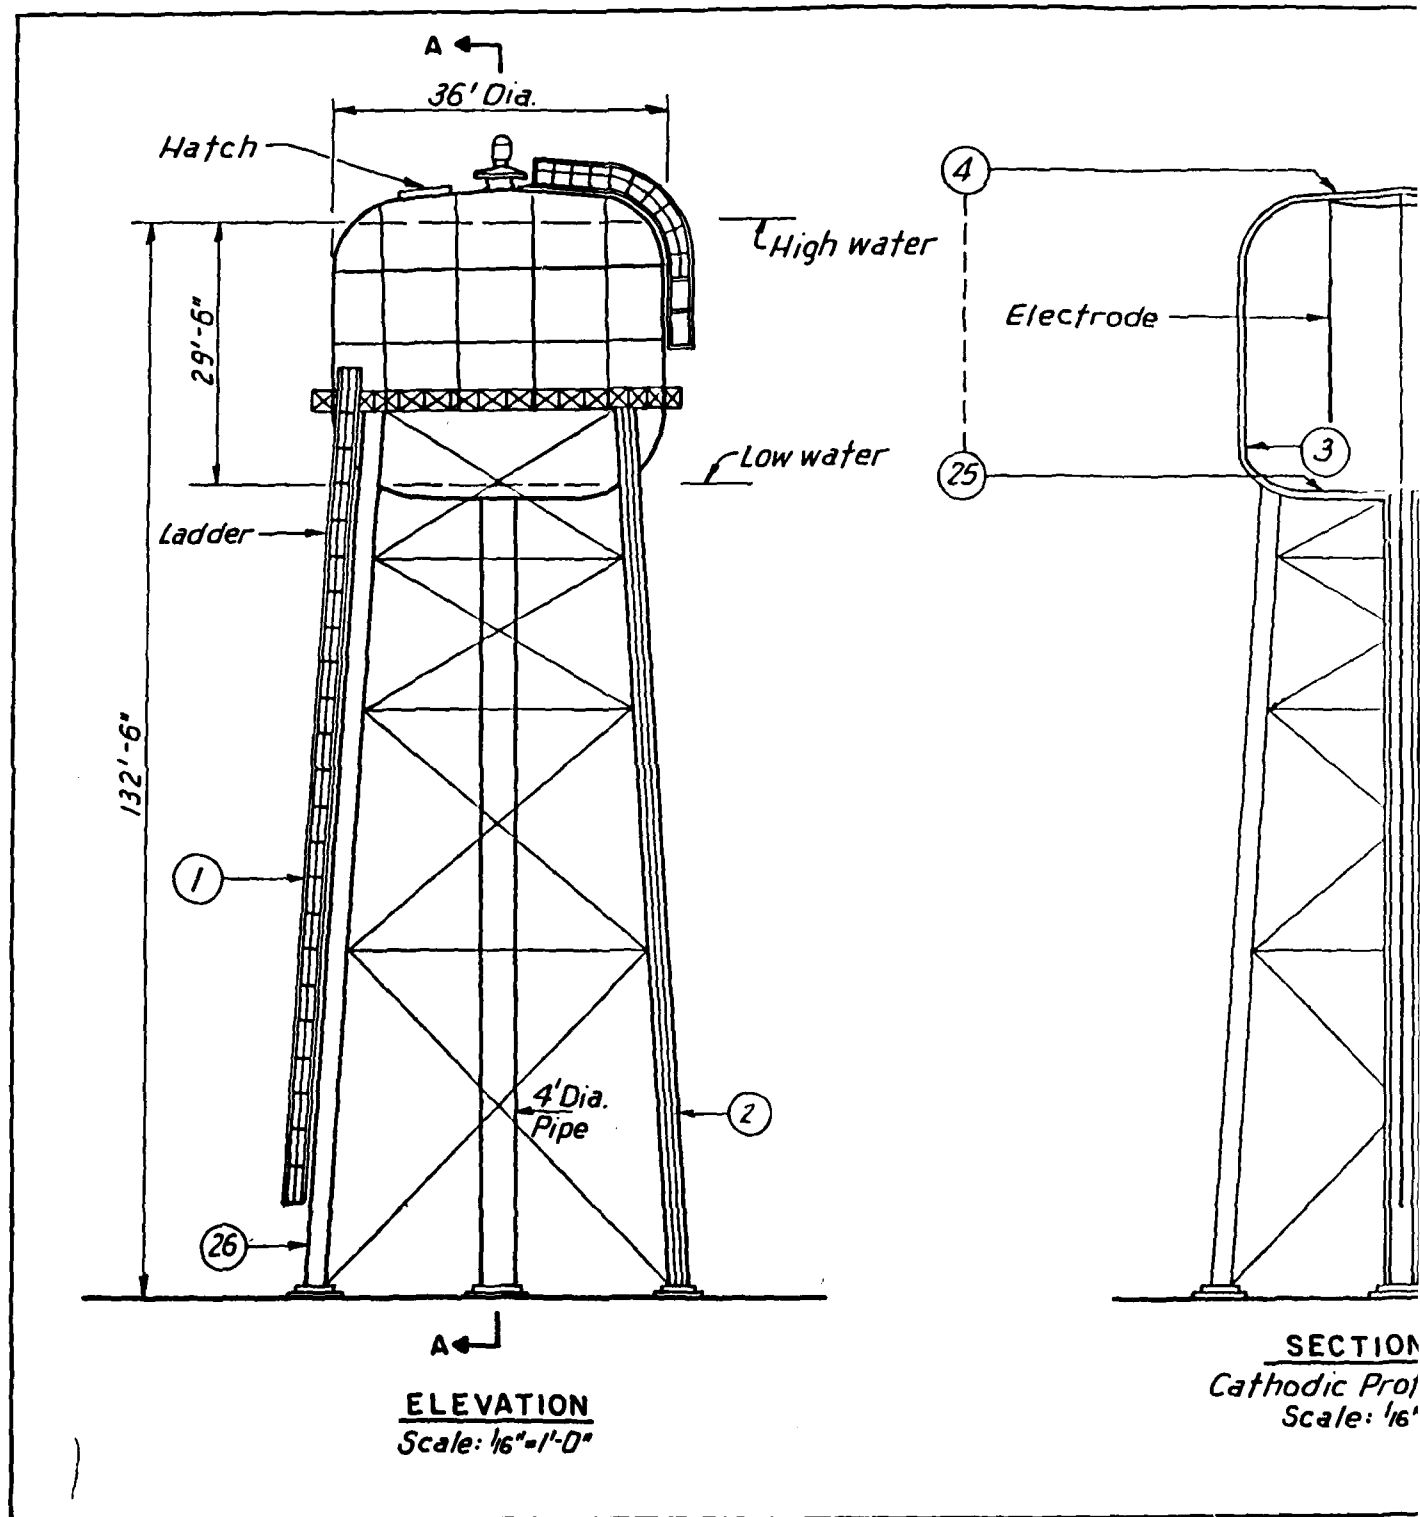
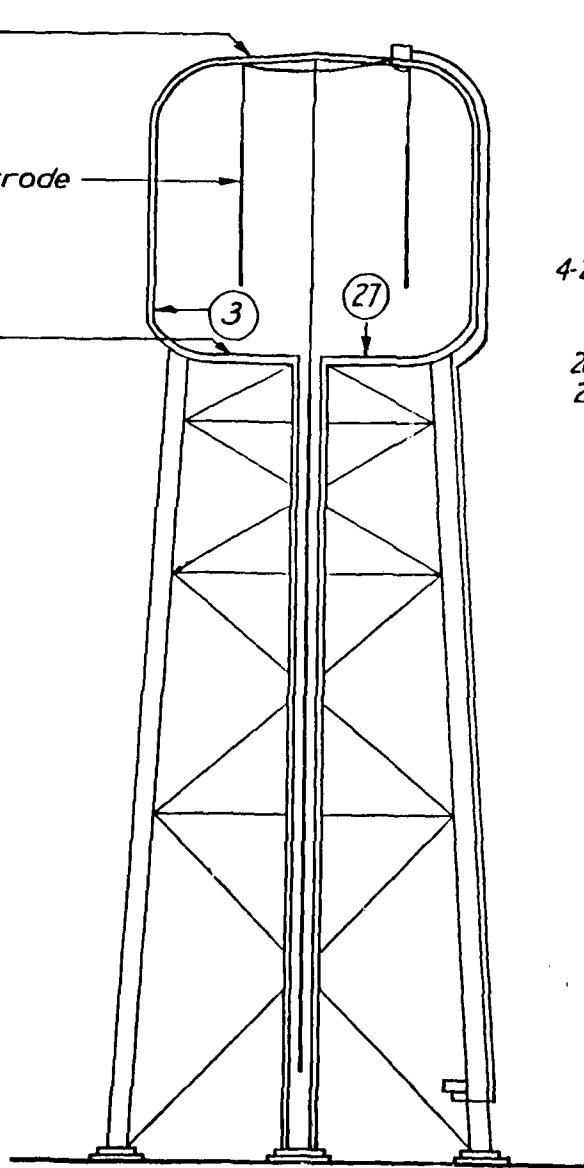
COLLINS ENGINEERS, INC. 888 W. JACKSON CHICAGO, ILLINOIS	CHESAPEAKE DIVISION NAVAL FACILITIES ENGINEERING COMMAND WASHINGTON, D.C. NAVAL AMPHIBIOUS BASE, LITTLE CREEK NORFOLK, VA.	
	FACILITY 3850 CONTRACT No. N00477-85-D-0387	FIG. NO. 4.3

1. Ladder and safety cage are heavily pitted and several of the rungs are bent.
2. Crack in weld of pipe support.
3. Areas of light to moderate corrosion on interior
- 4-25 Ultrasonic thickness measurements. Measurements taken at approximately 2" intervals. Values given in table below.
26. Pitted areas on column.
27. Approximately 3 inches of sediment on bottom.

ULTRASONIC THICKNESS MEASUREMENTS			
4	0.30"	16	0.34"
5	0.27"	17	0.32"
6	0.29"	18	0.33"
7	0.28"	19	0.35"
8	0.28"	20	0.33"
9	0.28"	21	0.44"
10	0.27"	22	0.52"
11	0.29"	23	0.46"
12	0.28"	24	0.44"
13	0.41"	25	0.50"
14	0.40"		
15	0.39"
